Service Information

To : ICOM Distributors
From : ICOM Inc. / CS Department
Ref No. : ZSM00010
Date : March 14, 2006

IC-7000 : Stop the AF 8 kHz Tone Noise

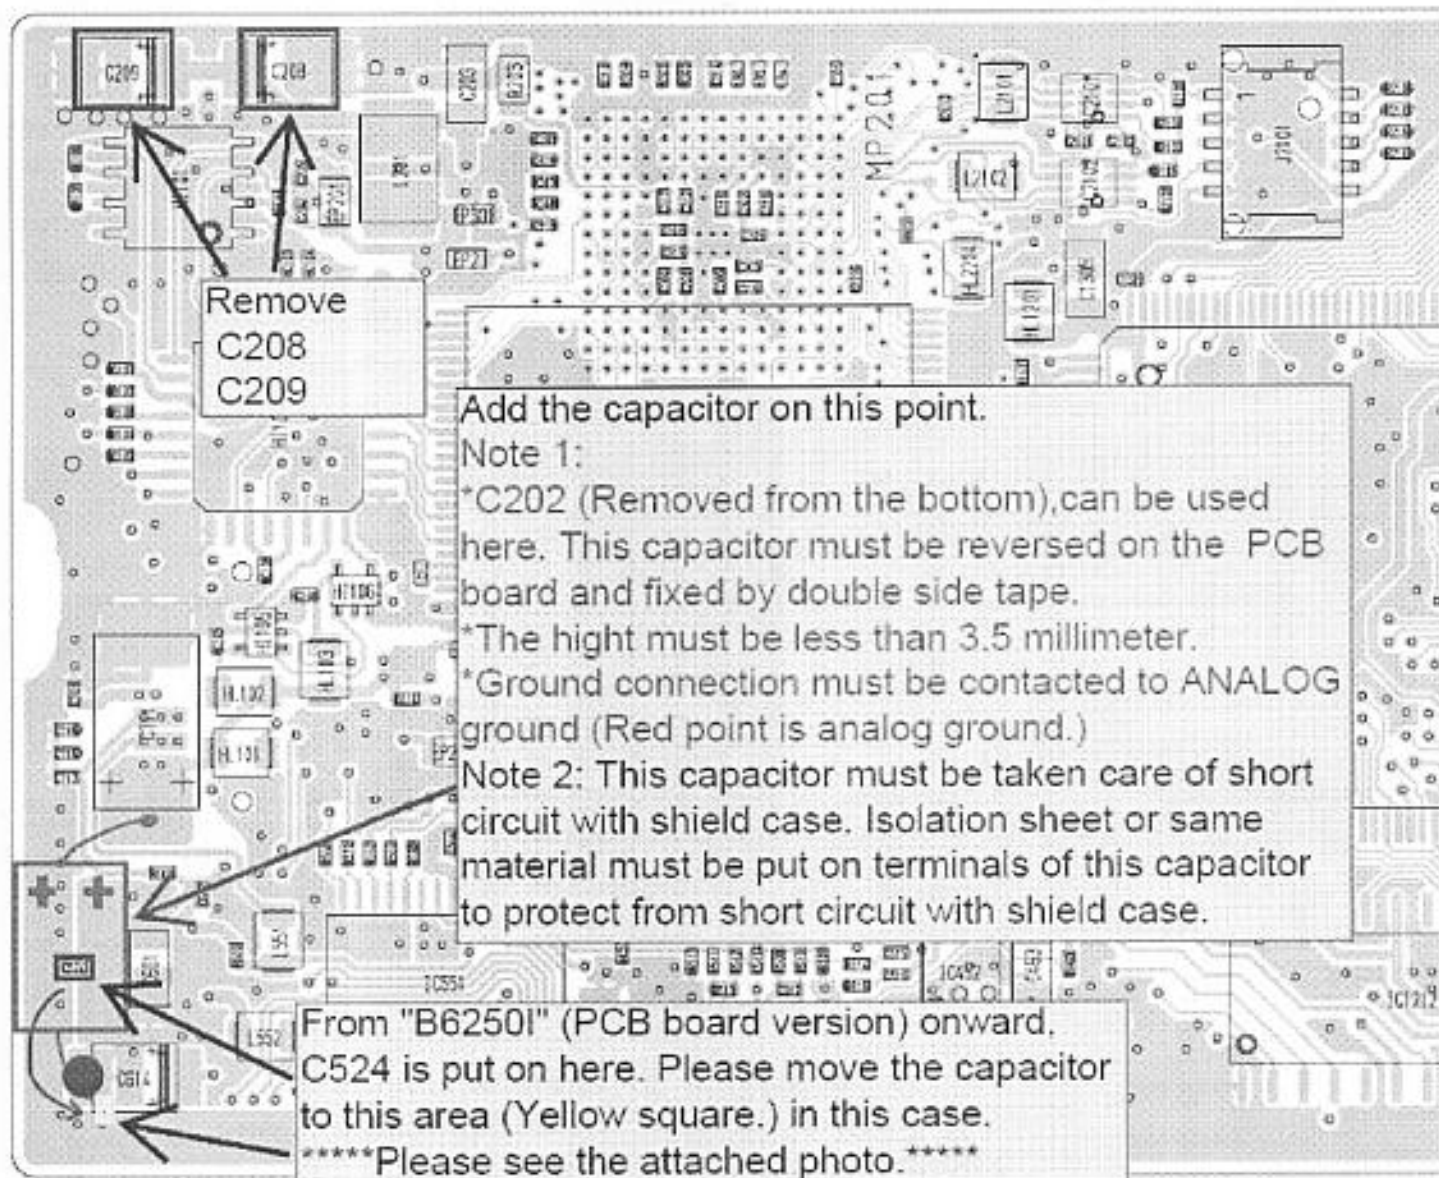
<IC-7000 LOGIC UNIT : TOP VIEW>

Some IC-7000 transceivers may have the symptom of 8 kHz Tone Noise in AF. This noise appears when hearing AF with headphone. From Rear EXT SP jack, stronger noise appears compared to FRONT PHONE/SPEAKER jack. The following is how to stop this noise.

1. Model IC-7000
2. How to improve Change the location of capacitors
3. Replace parts Remove capacitors from LOGIC UNIT

Ref. NO.	Part NO.
C207	4030018960 C3216 JB 1C 106MT-N
C208	4550006780 TEESVB2 0J 476M8R
C209	4550006780 TEESVB2 0J 476M8R
C202	4550007310 F930 J227MNMBMA
(Replace)	Replace C202 form the bottom → top of the LOGIC UNIT
